Belzona SuperWrap II repairs and strengthens ash chutes

ID: 9325

Industry: Other
Application: SHM-Solids Handling Machinery

Customer Location: Bristol
Application Date: March 2024

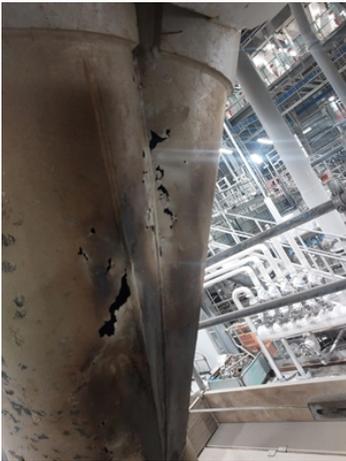
The customer burns non-recyclables and re-use the energy from the combustion. The ash left from burning comes down the chutes wearing holes due to sliding abrasion specifically on the elbows and joints where the ash has more contact.

Ash chute had worn due to sliding abrasion
