# BELZONA SUPERWRAP II APPLICATION ON MONEL 400 BELLOWS BETWEEN CONVOLUTIONS

Application: TCC-Tanks and Chemical Containment Areas

Products: Belzona 1511 (Super HT-Metal), Belzona 1983 (SuperWrap II)

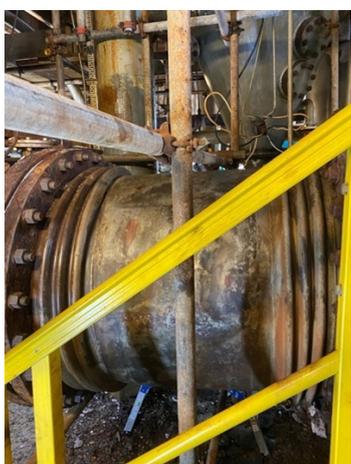
There was a small crack in the Monel which needed terminating and filling with Belzona 1511. The bellow also required strengthening.

Worn and cracked bellows between two convolutions

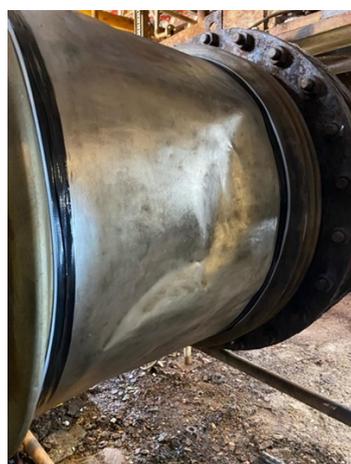
Crack in the bellows terminated and filled with Belzona 1511

Surface preparation was done using manual tools removing rust and debris from the surface taking care not to penetrate the 2mm thick Monel Bellow. The crack was terminated and filled with Belzona 1511.

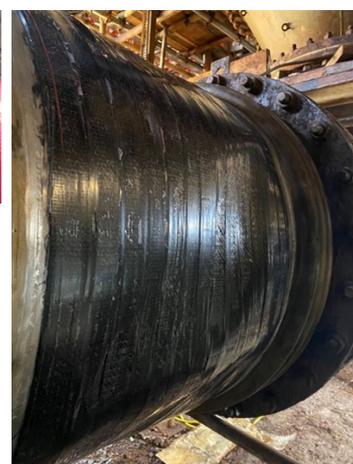
Completed temporary solution for cracked and worn bellow

Due to site imposed limitations, the repair was carried out as a temporary solution.

Belzona 1983 was then applied to increase strength and durability of the bellow.
