BELZONA SUPERWRAP II APPLICATION ON MONEL 400 BELLOWS BETWEEN CONVOLUTIONS

ID: 9327

Products: Belzona 1511 (Super HT-Metal), Belzona 1983 (SuperWrap II)

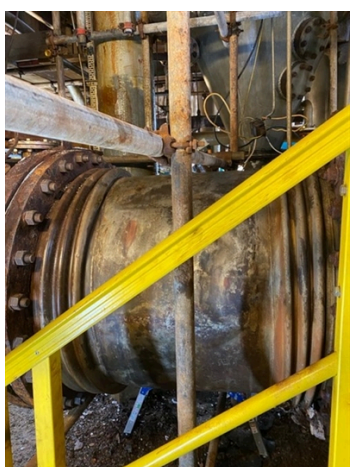
There was a small crack in the Monel which needed terminating and filling with Belzona 1511. The bellow also required strengthening.

Worn and cracked bellows between two convolutions
