BELZONA SUPERWRAP II APPLICATION ON MONEL 400 BELLOWS BETWEEN CONVOLUTIONS

ID: 9327

Industry: Chemical & Petrochemical
Application: TCC-Tanks and Chemical Containment Areas

Customer Location: Runcorn
Application Date: March 2024

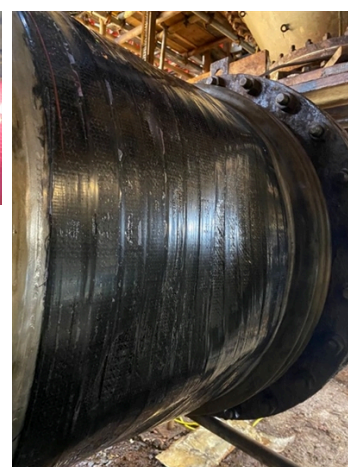
Completed temporary solution for cracked and worn bellow

Due to site imposed limitations, the repair was carried out as a temporary solution.

Belzona 1983 was then applied to increase strength and durability of the bellow.
