Protection of stainless-steel scrubber vessel from chemical attack

ID: 9328

Application: TCC-Tanks and Chemical Containment Areas

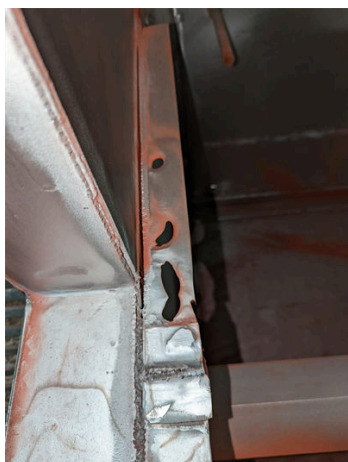
Newly fabricated stainless-steel scrubber vessels were put in service without a coating thinking the stainless-steel will provide enough protection. After 3 months they were having through wall defects in several parts of the vessel.

Vessel initially after chemical attack.

The whole vessel was grit blasted. They had welds and irregular surfaces which were smoothed and filled with Belzona 1111. Then Belzona 1111 was frost blasted and two coats of Belzona 4311 were applied.

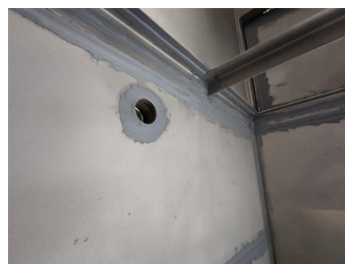
Weld seams and gaps covered with Belzona 1111.

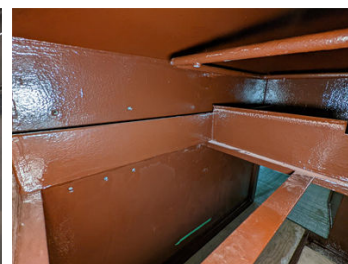
After application of two coats of Belzona 4311.

We were able to secure the job as we created coated samples for the customer and sent them for immersion testing. The product performed well so they decided to proceed with the application. The vessel was opened after 3 months and then after 1 year and the coating was still in good shape protecting the vessel.
