Main Station Transformer flange sealed with Belzona 3412

ID: 9329

Industry: Power
Application: GSS-Gaskets, Seals and Shims
Substrate: Carbon steel
Products: Belzona 3412, Belzona 8411

Customer Location: Ireland
Application Date: March 2023

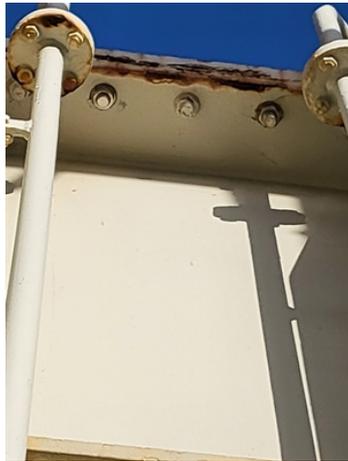
Main Station transformer

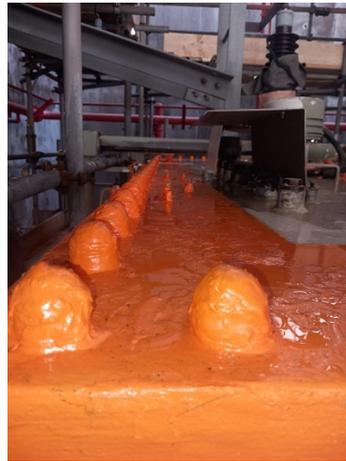
The area around the top flange of the transformer was corroding. The corrosion was also effecting the bolts. The flange area has been recoated with paint on three occasions, however this had not produced a satisfactory solution. There was a gap between the flanges of approximately 10mm. This gap was up to 100mm deep. There was potential movement between the flanges due to thermal expansion or other factors.

Typical corrosion at the main flange

The existing paint and corrosion were removed by grit blasting and the flange was re-painted. Belzona 8411 and Belzona 3412 were applied in accordance with Belzona 3412 Instructions for Use

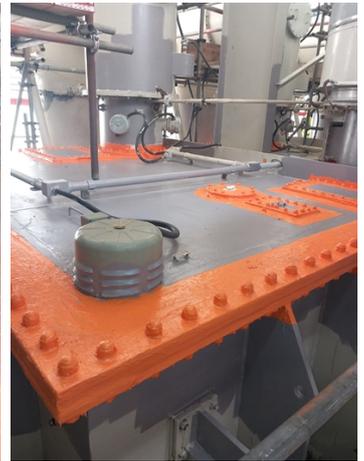
Close up of Belzona 3412 seal on the flange

Belzona 3412 was the ideal solution as it would provide long term corrosion protection, would accommodate flexibility in the joint and would allow for planned inspections of the flange and bolts in the future.
