# Main Station Transformer flange sealed with Belzona 3412

Industry: Power  
Application: GSS-Gaskets, Seals and Shims  
Substrate: Carbon steel  
Products: Belzona 3412, Belzona 8411

Customer Location: Ireland  
Application Date: March 2023

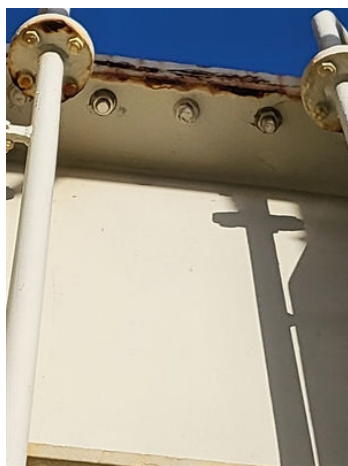
The area around the top flange of the transformer was corroding. The corrosion was also effecting the bolts. The flange area has been recoated with paint on three occasions, however this had not produced a satisfactory solution. There was a gap between the flanges of approximately 10mm. This gap was up to 100mm deep. There was potential movement between the flanges due to thermal expansion or other factors.

Typical corrosion at the main flange

The existing paint and corrosion were removed by grit blasting and the flange was re-painted.

Belzona 8411 and Belzona 3412 were applied in accordance with Belzona 3412 Instructions for Use

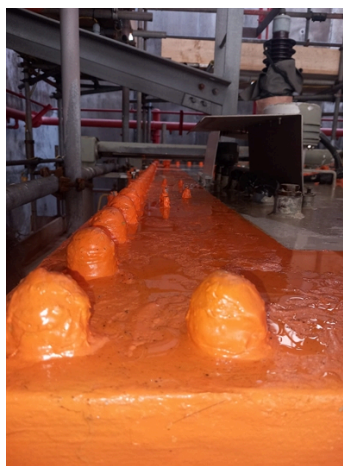
Close up of Belzona 3412 seal on the flange

Belzona 3412 was the ideal solution as it would provide long term corrosion protection, would accommodate flexibility in the joint and would allow for planned inspections of the flange and bolts in the future.

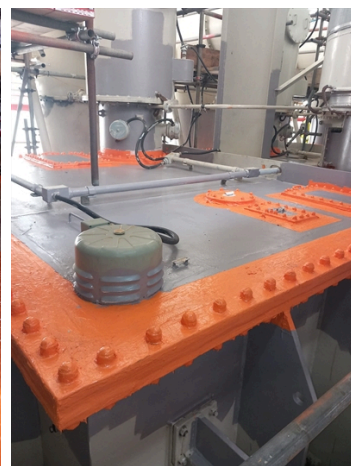
Belzona 3412
