Pipe Strengthening with Belzona SuperWrap II

ID: 9330

Application: VPF-Valves, Pipes and Fittings

Application Date: November 2020

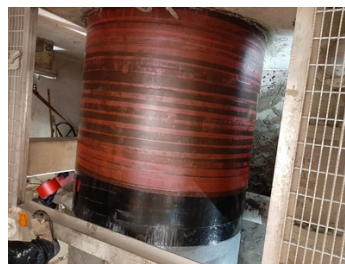
Wrapping in 4 foot sections

First, the pipe was grit blasted and prepared according to SSPC SP10. All the pitting and resurfacing was then done with Belzona 1121(Super XL-Metal) because of its longer overcoating time. The next day, they started applying Belzona SWII. They applied the wrap in 4 foot sections at a time, so every 4 feet they would consolidate the repair with Belzona 9382 and continue with the next section. Though the application was during colder climate, Belzona 1982 was chosen to give more working life and allow the crew to complete the application properly.

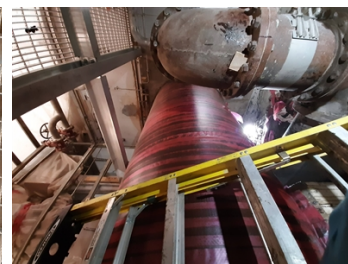
Wrap completed and consolidated with Belzona 9382

Customer received an ISO/ASME compliant repair system able to stop the corrosion, return the mechanical strength back to the water pipe and designed to provide a 20 year lifetime.
