# Protection of Wastewater Centrifuge

ID: 9331

Industry: Water / Wastewater

Customer Location: Pickering, Ontario

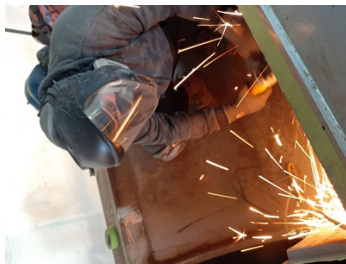
During surface preparation

The steel substrate was prepared to and in accordance with SSPC-SP 11, Bare Metal Power Tool Cleaning. This method of surface preparation was chosen as the plant was in operation and abrasive blasting was not an option. Once the substrate was prepared, Belzona 1111 was applied as a stripe coat to smooth out any defects, joints and seams. Belzona 1341 was then applied in two coats of alternate colors.

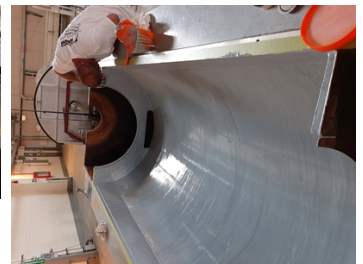
Finished application

Belzona 1341 has proven successful in protecting the equipment from erosion-corrosion but also in reducing the scaling and improving the efficiency of the equipment.
