Protection of Wastewater Centrifuge

ID: 9331

Products: Belzona 1111 (Super Metal), Belzona 1341 (Supermetalglide)

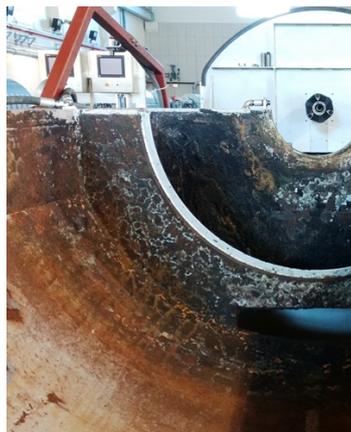
The centrifuge was suffering from erosion-corrosion and scale buildup. They needed a product that would protect the equipment but also help reduce the buildup and improve the efficiency of the equipment.

Original corroded substrate

The steel substrate was prepared to and in accordance with SSPC-SP 11, Bare Metal Power Tool Cleaning. This method of surface preparation was chosen as the plant was in operation and abrasive blasting was not an option. Once the substrate was prepared, Belzona 1111 was applied as a stripe coat to smooth out any defects, joints and seams. Belzona 1341 was then applied in two coats of alternate colors

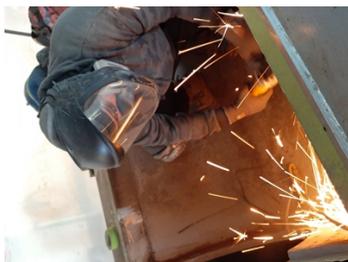
During surface preparation

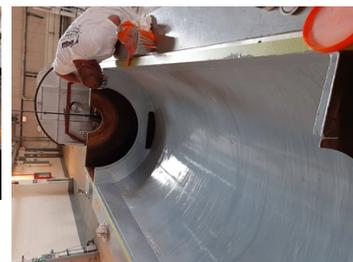
First Coat Application
