Belzona Trials New SF6 Leak Solution

ID: 9332

Industry: Power
Application: GSS-Gaskets, Seals and Shims
Substrate: Aluminum
Products: Belzona 1981 (SuperWrap II), Belzona 7311

Customer Location: Lackenby, Cleveland
Application Date: November 2023

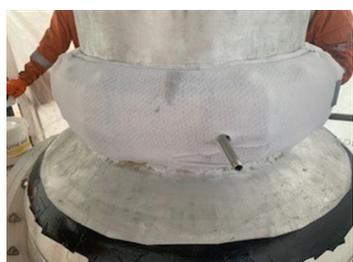
SF6 flange following surface preparation to SSPC-SP11, installation of the Backing Rod, tape, Redirection Nozzle & Breather Membrane.

The substrate (Aluminium) was first prepared in accordance with SSPC-SP11 Surface Preparation using an MBX (using a Stainless Steel wheel to prevent bi-metallic contamination). Once prepared, a backing-rod was applied behind the flange bolts and tape was applied over the bolts themselves (this prevents Belzona from adhering to them and allows a smoother surface transition). A Breather Membrane was applied around the circumference of the flange encapsulating it in its entirety, a Redirection Nozzle was also fitted to channel the leaking gas. Belzona 7311 was then applied to seal the membrane prior to the application of the impregnated Belzona 9341 (Reinforcement Sheet). The newly applied Belzona 7311 was then wetted out using Belzona 1981 (Winter Grade) SWII Resin prior to the application of 5 x wraps of Belzona 9371 (SWI Reinforcement Sheet) forming 10-layers (due to the 50% overlap). This was then left to polymerise (generating a slight self-curing exotherm) prior to a final encapsulating layer of Belzona 7311. The application required approximately 6L of Belzona 7311 & 5L of Belzona 1981. The application was carried out in accordance with a modified version of Belzona System Leaflet VPF-12.

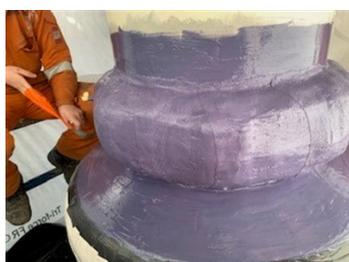
Wetting out of the Breather Membrane and vertical application of Reinforcement Sheets (Belzona 9341) using Belzona 7311.

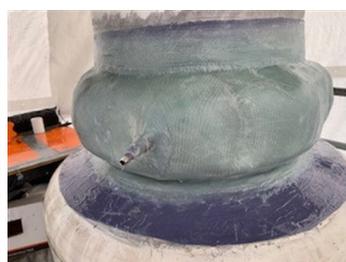
Post-application of 5x wraps of reinforcement sheet (Belzona 9371) and Belzona 1981 resin.

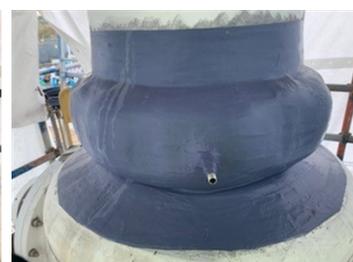
Final application after a further encapsulating layer of Belzona 7311.

Belzona conducted this application on a trial basis and had to reduce the leak by a minimum of 80%. The application was undertaken within a 12-hour shift.

The solution was classed as successful after 3-months of service and is now being rolled out at other national substations across the UK
