# Belzona Trials New SF6 Leak Solution

ID: 9332

**Industry:** Power  
**Application:** GSS-Gaskets, Seals and Shims  
**Substrate:** Aluminum  
**Products:** Belzona 1981 (SuperWrap II), Belzona 7311

**Customer Location:** Lackenby, Cleveland  
**Application Date:** November 2023

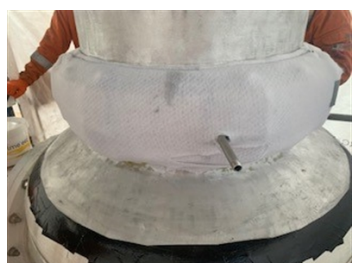
SF6 flange following surface preparation to SSPC-SP11, installation of the Backing Rod, tape, Redirection Nozzle & Breather Membrane.

The substrate (Aluminium) was first prepared in accordance with SSPC-SP11 Surface Preparation using an MBX (using a Stainless Steel wheel to prevent bi-metallic contamination). Once prepared, a backing-rod was applied behind the flange bolts and tape was applied over the bolts themselves (this prevents Belzona from adhering to them and allows a smoother surface transition). A Breather Membrane was applied around the circumference of the flange encapsulating it in its entirety, a Redirection Nozzle was also fitted to channel the leaking gas. Belzona 7311 was then applied to seal the membrane prior to the application of the impregnated Belzona 9341 (Reinforcement Sheet). The newly applied Belzona 7311 was then wetted out using Belzona 1981 (Winter Grade) SWII Resin prior to the application of 5 x wraps of Belzona 9371 (SWI Reinforcement Sheet) forming 10-layers (due to the 50% overlap). This was then left to polymerise (generating a slight self-curing exotherm) prior to a final encapsulating layer of Belzona 7311. The application required approximately 6L of Belzona 7311 & 5L of Belzona 1981. The application was carried out in accordance with a modified version of Belzona System Leaflet VPF-12.

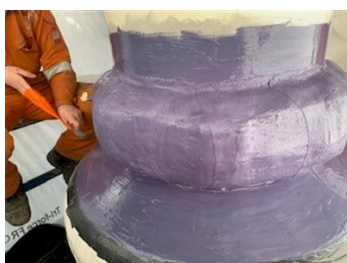
Wetting out of the Breather Membrane and vertical application of Reinforcement Sheets (Belzona 9341) using Belzona 7311.
