PETROCHEMICAL FLANGE ENCAPSULATION

ID: 9333

Industry: Chemical & Petrochemical
Application: VPF-Valves, Pipes and Fittings
Substrate: Carbon steel
Products: Belzona 3412, Belzona 8411

Customer Location: Ontario Sarnia
Application Date: October 2017

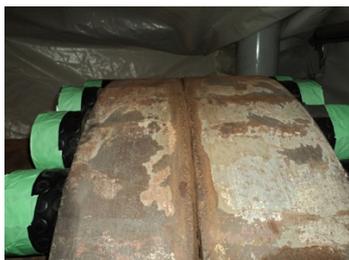
Preparation performed using hand tooling completed.

Before application of the product, the surface of the flanges was prepared and cleaned with power tools and cleaner degreaser. To seal the gap between the flange faces, a strip of bridging tape was used. Belzona 8411 was then applied to the entire application surface. After, rubber caps were installed over the bolts and nuts.

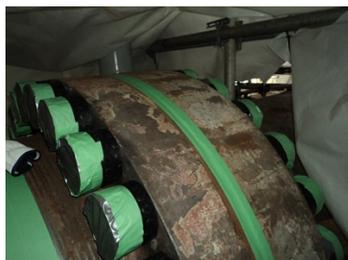
Flanges ready for Belzona 8411 release agent inhibitor.

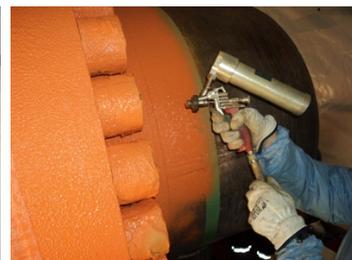
Application of Belzona 3412 encapsulating membrane.
