Glass coated pipe in very acidic service at 250 F temperature in need of repair.

ID: 9334

Industry: Chemical & Petrochemical
Application: VPF-Valves, Pipes and Fittings
Substrate: Carbon steel
Products: Belzona 1511 (Super HT-Metal), Belzona 1593

Customer Location: Saint Gabriel, LA
Application Date: April 2024

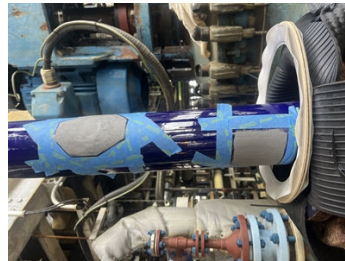
Area's being addressed during the repair. Belzona 1511 was applied for pit filling then Belzona 1593 was applied and tied into the glass liner for added protection of the repaired areas.

A battery operated MDX Bristle Blaster was used to prepare the area. The area was cleaned with 9111. Then a Belzona application tool and a short bristled paint brush were used for the application of Belzona 1511 and Belzona 1593.

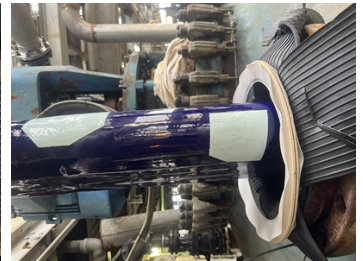
This is the completed repair, curing and waiting to be put back into service. Great job by the repair team.
