Glass coated pipe in very acidic service at 250 F temperature in need of repair.

ID: 9334

Industry: Chemical & Petrochemical
Application: VPF-Valves, Pipes and Fittings
Substrate: Carbon steel
Products: Belzona 1511 (Super HT-Metal), Belzona 1593

Customer Location: Saint Gabriel, LA
Application Date: April 2024

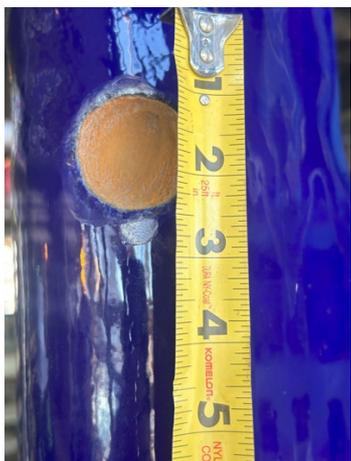
A pipe inside a glass lined tank had suffered a failure in the glass liner causing pitting in 2 areas on the pipe. The pitting needed to be filled in and over coated for protection from the harsh service environment.

This was the most damaged area on the glass coated pipe. 1 1/2" x 1 1/2" x 1/2"

Area's being addressed during the repair. Belzona 1511 was applied for pit filling then Belzona 1593 was applied and tied into the glass liner for added protection of the repaired areas.

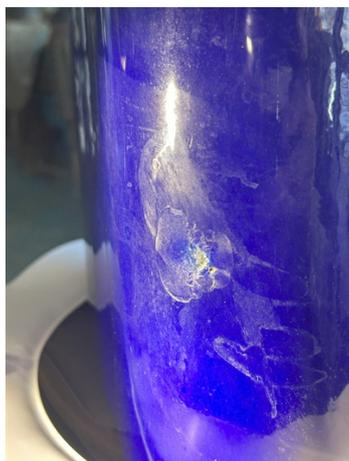
Smaller damaged area of glass coated pipe.

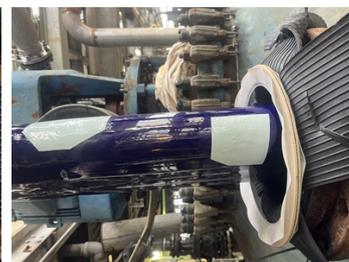
This is the completed repair, curing and waiting to be put back into service. Great job by the repair team.
