Pipe in a wastewater pumping station reinforced with Belzona SWII

ID: 9337

Application: VPF-Valves, Pipes and Fittings

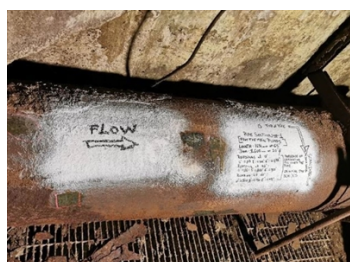
The pipe section was suffering from general external corrosion. The pipe had become weakened from severe metal loss. This pipe section never got flooded nor exposed to immersion conditions. Yet, there was a lot of moisture in the environment.

Corroded pipe with severe metal loss

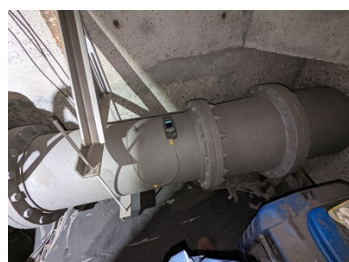
Blasted pipe and measuring environmentals

The substrate was grit blasted to near white metal. Since there was a lot of moisture and high humidity, the contractor had to install a dehumidifier to control the environment. The pitting and irregular surfaces were rebuilt and smoothed with Belzona 1121. Then 2 wraps of Belzona SWII were applied to strengthen the weakened pipe. The resin selected for this application was Belzona 1982. Two coats of Belzona 5811 were applied to protect the flanges.

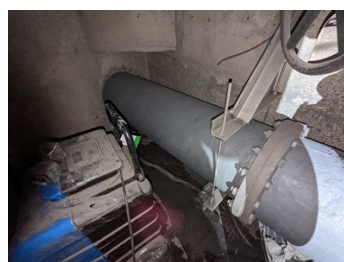
Resurfaced with Belzona 1121

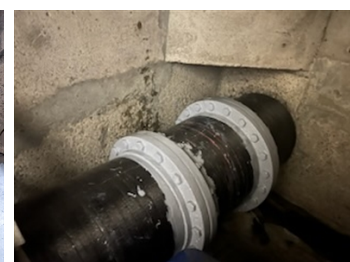
Application completed with SWII reinforcement and coated flanges

The selling point of the application was the engineering design we provided following ASME PCC2 standard for 20 years of protection. The application was carried out without disrupting the service of the pump station which was ideal for the customer as they could not afford to shutdown. The pipe was inspected after 1 year, the wrap and the coating were still in perfect condition.
