Pipe in a wastewater pumping station reinforced with Belzona SWII

ID: 9337

Application: VPF-Valves, Pipes and Fittings

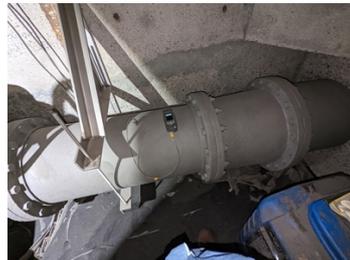
The pipe section was suffering from general external corrosion. The pipe had become weakened from severe metal loss. This pipe section never got flooded nor exposed to immersion conditions. Yet, there was a lot of moisture in the environment.

Corroded pipe with severe metal loss

The substrate was grit blasted to near white metal. Since there was a lot of moisture and high humidity, the contractor had to install a dehumidifier to control the environment. The pitting and irregular surfaces were rebuilt and smoothed with Belzona 1121. Then 2 wraps of Belzona SWII were applied to strengthen the weakened pipe. The resin selected for this application was Belzona 1982. Two coats of Belzona 5811 were applied to protect the flanges.

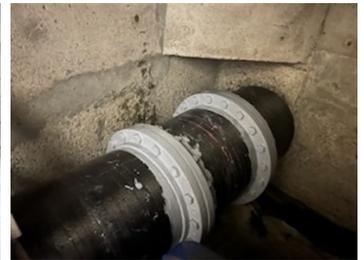
Resurfaced with Belzona 1121
