# Refurbishment and protection of Water-Polymer Mixture Tank from further corrosion

ID: 9338

Industry: *Water / Wastewater*  
Application: *TCC-Tanks and Chemical Containment Areas*  
Substrate: *Carbon steel*  
Products: *Belzona 5811 (Immersion Grade)*

Customer Location: *Ontario, Canada*  
Application Date: *August 2023*

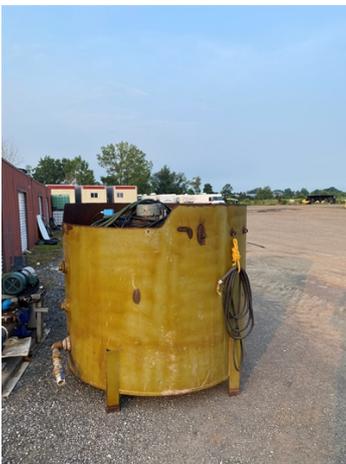
*Tank was very badly corroded and required refurbishment and protection*

Tank exterior prior to application.

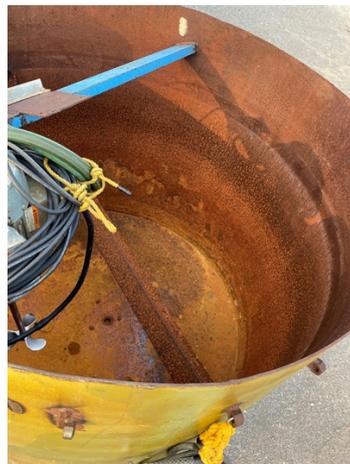
Tank interior prior to application.

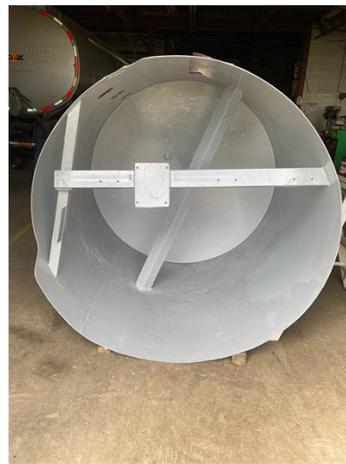
After sand blasting and application of two coats of Belzona 5811

All the elbows were grit blasted to SSPC SP10 and two coats of Belzona 5811 were applied.
