Chemically damaged floor rebuilt and protected with Belzona

ID: 9339

Application: FPA-Floor Problem Areas

Substrate: Concrete

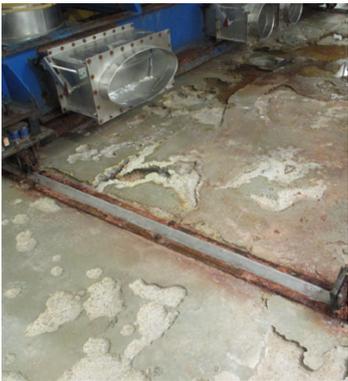
Manufacturing plant that processes Bio-based succinic acid was having issues with their floors. Dry process material of Bio-based succinic acid was being spill onto the concrete floor and during floor washing operations, water activated the acid and this one started to attack the concrete.

Floor damage caused by Succinic Acid

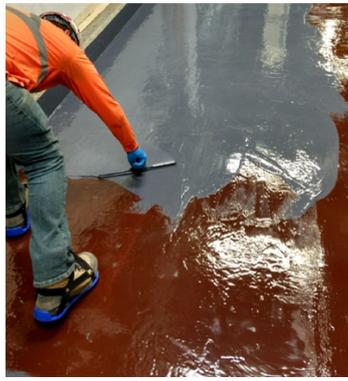
Applying second coat of Belzona 4311

The damaged concrete was washed and decontaminated. Missing concrete areas were refurbished and smooth out. 2coats of Belzona 4311 (Magma CR1) were applied to prevent future deterioration of the concrete via chemical attack.

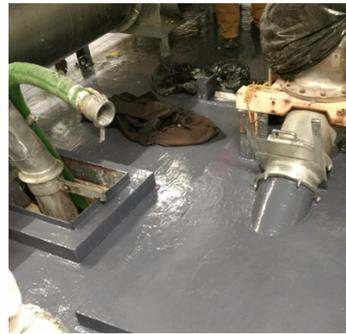
Second coat of Belzona 4311 around floor step up's and piping equipment through floor.

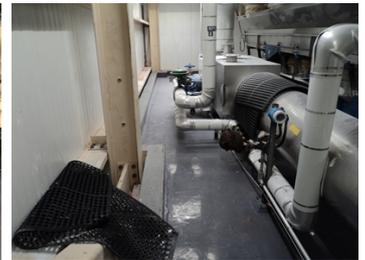
Finished floor coating Belzona 4311
