# Repair of wear and through wall defect on Volute of Pumps and Protection of Pumps from further corrosion

ID: 9340

Application: CEP-Centrifugal Pumps

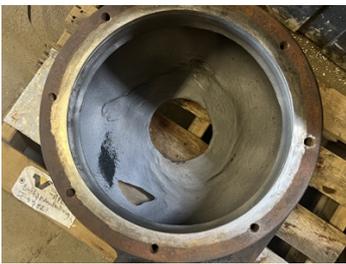
First pump with through wall after grit blasting.

Pumps were grit blasted to SSPC SP10. First pump was rebuilt, hole repaired using a metal plate and entire interior covered with Belzona 1111. Wear on inside of pump 2 also rebuilt using Belzona 1111. Afterwards, two coats of Belzona 1321 were applied to both pumps.

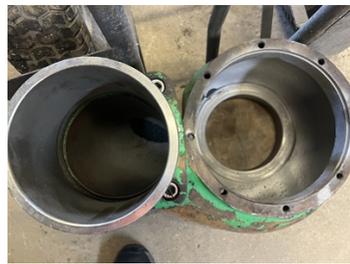
Second pump with wear after blasting

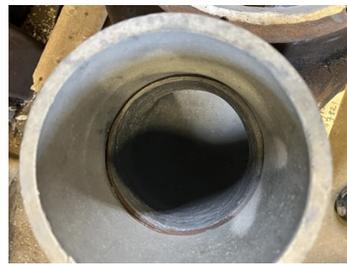
After rebuilding wear on pump with Belzona 1111.

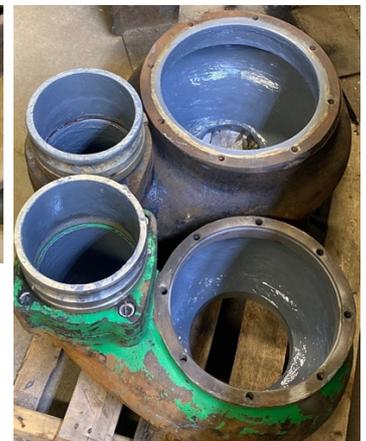
First pump after plate bonding with Belzona 1111 and both pumps lined with Belzona 1321.
