# Weakened pipe reinforced with plate bonding and SW

ID: 9342

Application: VPF-Valves, Pipes and Fittings

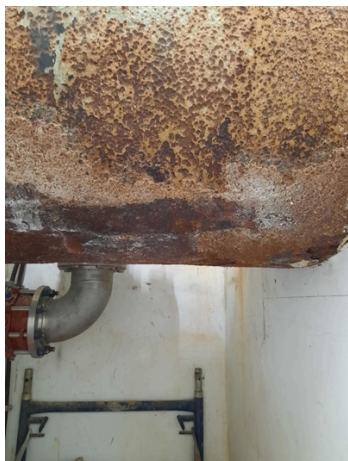
A pipe in a wastewater plant needed had suffered from external corrosion and metal loss over the years.

Defective pipe

The pipe was so deteriorated that they were concerned that abrasive blasting the bottom of the pipe will puncture the pipe and create through wall defects. It was decided to do a plate bonding with a surface tolerant product as an initial reinforcement before further reinforcing with SWII.

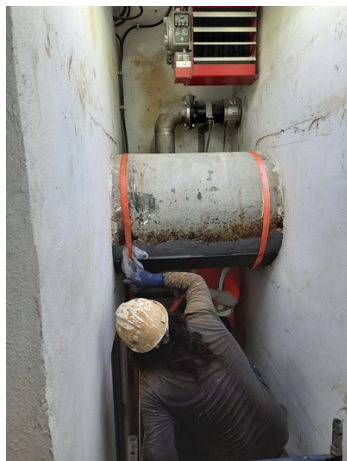
Plate bonding over the most critical area

First, the pipe was prepared as best as possible. Then we did a plate bonding repair with Belzona 1161 to protect the bottom section of the pipe. After, we grit blasted the rest of the pipe and reinforced the rest of the pipe with Belzona Superwrap II.

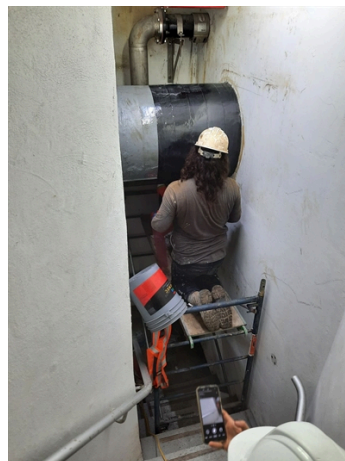
1st layer of Belzona SWII

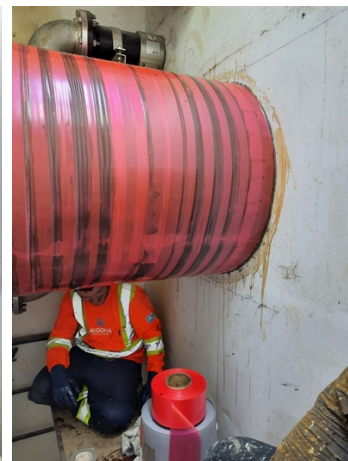
Complete repair after consolidating with the release film to be later removed
