Weakened pipe reinforced with plate bonding and SW

ID: 9342

Application: VPF-Valves, Pipes and Fittings

Application Date: May 2021

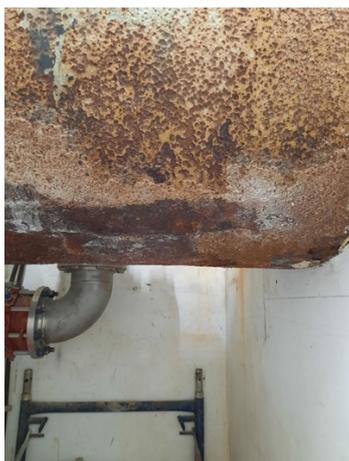
A pipe in a wastewater plant needed had suffered from external corrosion and metal loss over the years.

Defective pipe

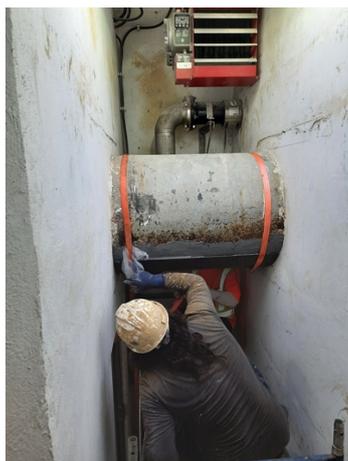
Plate bonding over the most critical area

The pipe was so deteriorated that they were concerned that abrasive blasting the bottom of the pipe will puncture the pipe and create through wall defects. It was decided to do a plate bonding with a surface tolerant product as an initial reinforcement before further reinforcing with SWII.

First, the pipe was prepared as best as possible. Then we did a plate bonding repair with Belzona 1161 to protect the bottom section of the pipe. After, we grit blasted the rest of the pipe and reinforced the rest of the pipe with Belzona Superwrap II.

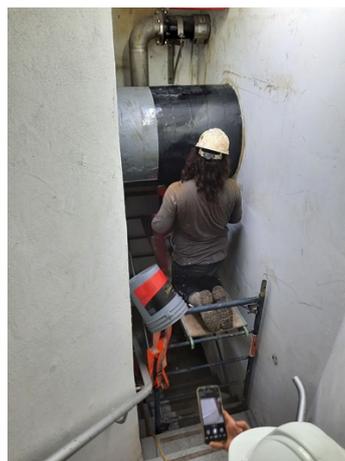
1st layer of Belzona SWII

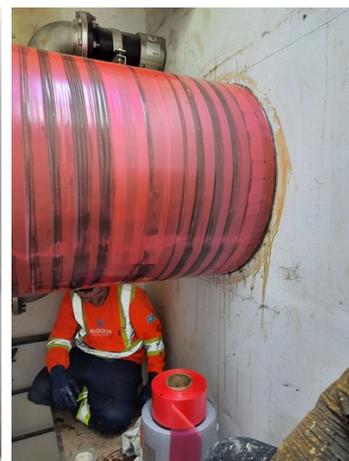
Complete repair after consolidating with the release film to be later removed
