Reviving Gray and Black Tanks Inside a Marine Vessel with Belzona Solutions

Application: *TCC-Tanks and Chemical Containment Areas*

Products: *Belzona 1111 (Super Metal), Belzona 5811 (Immersion Grade)*

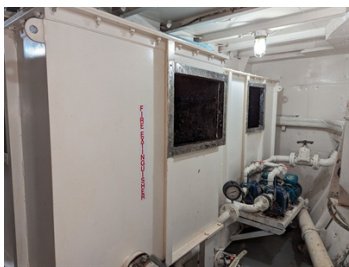
The gray and black tanks inside the marine vessel were suffering from coating failure and corrosion issues. The main flange also required repair from wear.

Tanks before surface preparation.

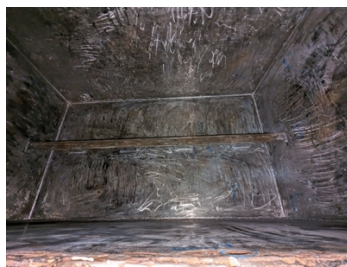
After surface preparation.

After solvent cleaning, and then with the use of a power tool, tank internal surfaces were prepared to SP11. Flanges were also rebuilt using Belzona 1111. Two coats of Belzona 5811 were then applied.

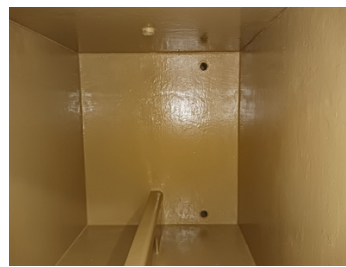
Gray Tank After application of two coats of Belzona 5811.

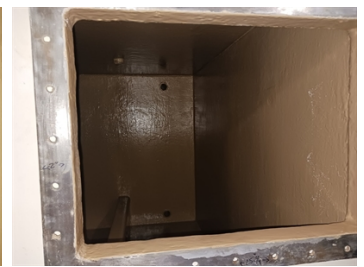
Black Tank After application of two coats of Belzona 5811.
