Stemming and Sealing High Voltage Transformer Oil Leak

ID: 9344

Industry: Power

Application: MPT-Mechanical Power Transmission

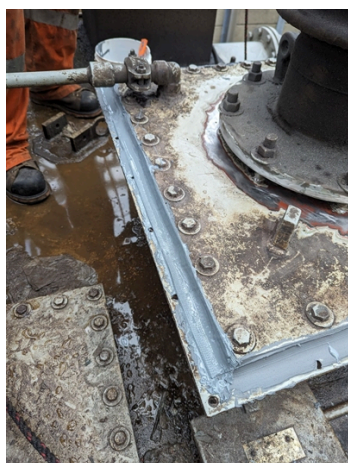
Customer was looking for a solution to stem and seal oil leakages from flanges and under the high voltage bushing pockets..

Leaks stemmed and sealed with Belzona 1161

Surface was wiped clean using solvent / degreaser and then prepared according to SP11 standards. Surface was wiped clean and leak sealed using Belzona 1161 and 9341. Afterwards, two coats of Belzona 5831 was applied.

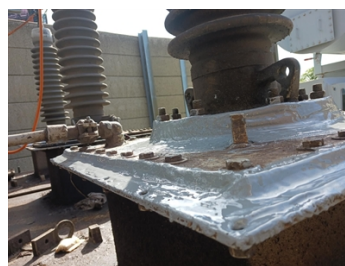
Coating to avoid permeation.
