# Stemming and Sealing High Voltage Transformer Oil Leak

ID: 9344

Industry: Power

Customer Location: Ontario, Canada

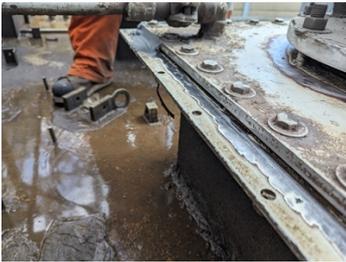
Transformer after surface preparation.

Surface was wiped clean using solvent / degreaser and then prepared according to SP11 standards. Surface was wiped clean and leak sealed using Belzona 1161 and 9341. Afterwards, two coats of Belzona 5831 was applied.

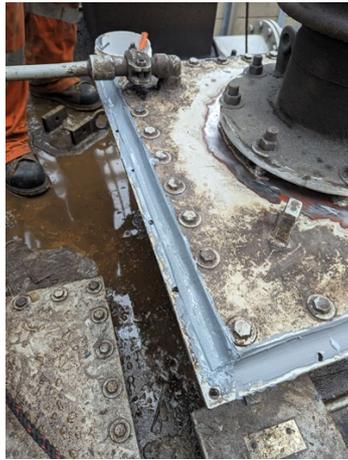
Leaks stemmed and sealed with Belzona 1161

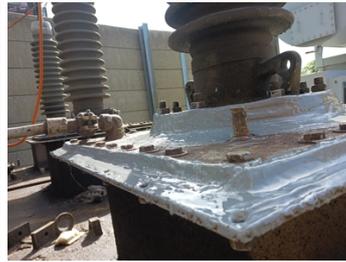
Coating to avoid permeation.
