Emergency repair on escalator handrail with Belzona products

ID: 9346

Customer Location: Toronto, Ontario
Application Date: August 2022

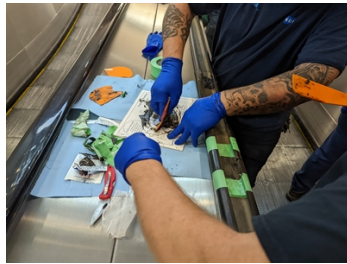
Mixing of Belzona 2311

The surface was roughened up and degreased. Then conditioner Belzona 2911 was applied and allowed to dry. The repair was then completed with Belzona 2311 with reinforcement tape 9341.
