# Emergency repair on escalator handrail with Belzona products

ID: 9346

Customer Location: Toronto, Ontario  
Application Date: August 2022

Substrate: Rubber  
Products: Belzona 2311 (SR Elastomer), Belzona 2911 (Elastomer QD Conditioner)

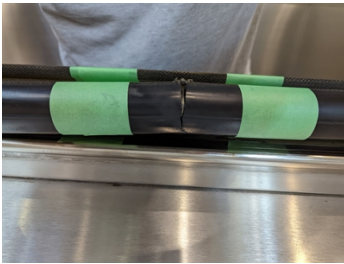
The handrail of an escalator had 2 defective areas. The side of the rubber was ripped and presented a potential safety hazard for the mall customers.

Damaged belt

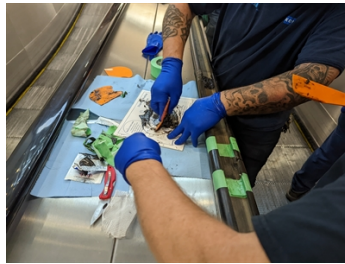
Mixing of Belzona 2311

The surface was roughened up and degreased. Then conditioner Belzona 2911 was applied and allowed to dry. The repair was then completed with Belzona 2311 with reinforcement tape 9341.

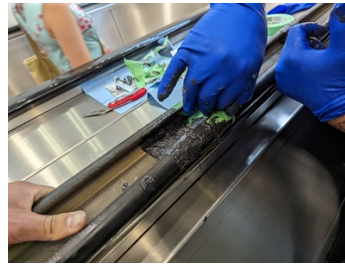
Removing masking tape after applying 2311

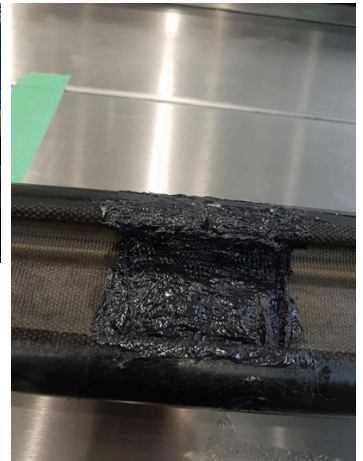
Completed repair

The product was applied and within 1 hour the product was sanded and put back in service. The customer was pleased with the quick turnaround.
