Emergency repair on escalator handrail with Belzona products

ID: 9346

Industry: *Buildings & Structures*
Application: *SHM-Solids Handling Machinery*

Substrate: *Rubber*
Products: *Belzona 2311 (SR Elastomer), Belzona 2911 (Elastomer QD Conditioner)*

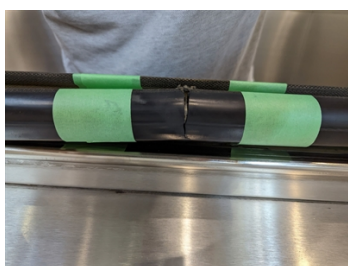
The handrail of an escalator had 2 defective areas. The side of the rubber was ripped and presented a potential safety hazard for the mall customers.

Damaged belt

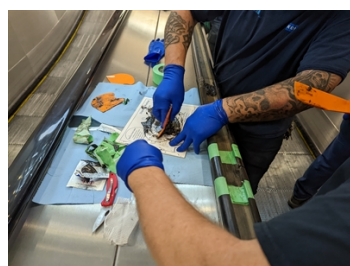
Mixing of Belzona 2311

The surface was roughened up and degreased. Then conditioner Belzona 2911 was applied and allowed to dry. The repair was then completed with Belzona 2311 with reinforcement tape 9341.

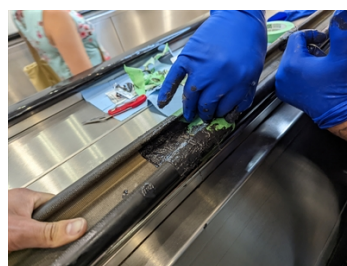
Removing masking tape after applying 2311

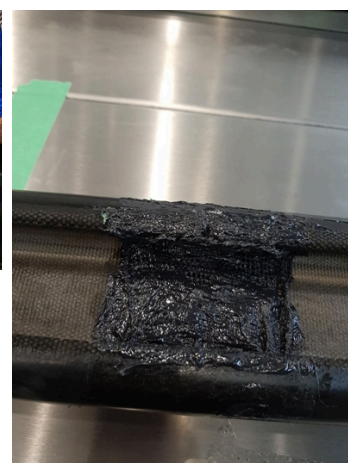
Completed repair

The product was applied and within 1 hour the product was sanded and put back in service. The customer was pleased with the quick turnaround.
