Coated Secondary Containment Areas

ID: 9347

Industry: Water / Wastewater
Application: FPA-Floor Problem Areas
Substrate: Concrete
Products: Belzona 4311 (Magma CR1), Belzona 4911 (Magma TX Conditioner), Belzona 5811 (Immersion Grade), Belzona 9111 (Cleaner Degreaser)

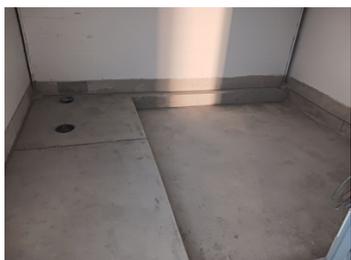
Preparation work completed

All concrete was ground using a grinder with a diamond Disc, all dust was vacuumed and area cleaned by using Belzona 9111, A mositsure test was performed to check the mositsure level content, it was below the 6% that is recommended. Three rooms required Belzona 4911 Magma Conditioner and Belzona 4311 Magma CR1 coating, the forth room required protection using Belzona 5811.

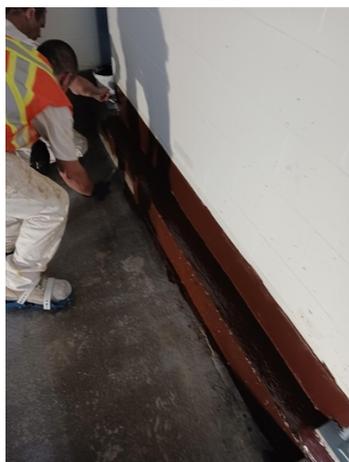
Application of first coat of Belzona 4311

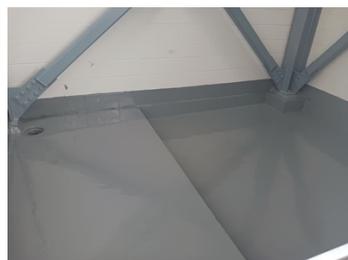
Application Belzona 4311 completed

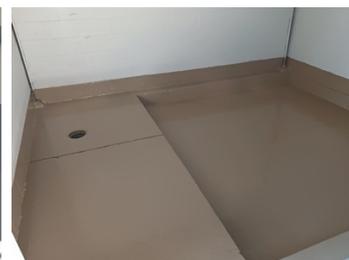
Application Belzona 5811 Completed
