BELZONA REBUILDS SEAL FACE ON RAW MILL AT CEMENT PLANT

ID: 935

Customer Location: *Cement Plant, Nazareth, Pennsylvania*
Application Date: *March, 2007*

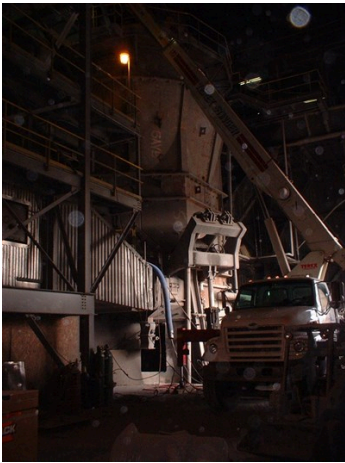
- * Raw mill overall size ,
- * Worn seal area on rotating table ,
- * Belzona® 1812 applied and new felt seal and holder installed ,
- * Another general view of the mill ,

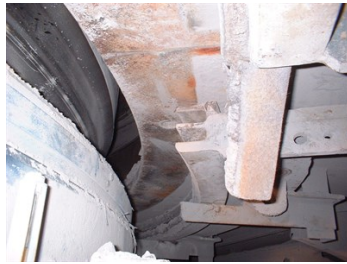
Abrasion from the felt seal and limestone wore this major component of the mill.
