BELZONA REBUILDS SEAL FACE ON RAW MILL AT CEMENT PLANT

ID: 935

Customer Location: *Cement Plant, Nazareth, Pennsylvania*
Application Date: *March, 2007*

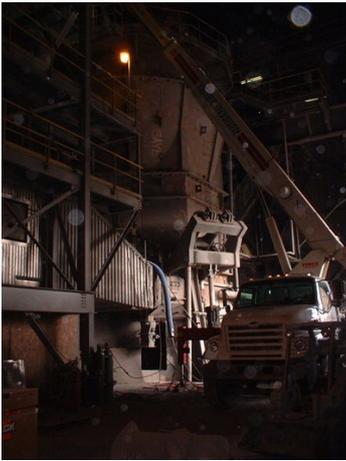
- * Raw mill overall size ,
- * Worn seal area on rotating table ,
- * Belzona® 1812 applied and new felt seal and holder installed ,
- * Another general view of the mill ,

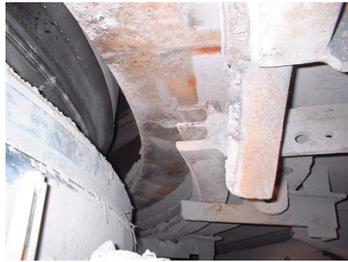
Abrasion from the felt seal and limestone wore this major component of the mill.

Application was carried out in accordance with Belzona Know-How System Leaflet SHM-13. Limited access only allowed hand grinding for preparation followed by application of the Belzona® 1812 by trowel.
