BELZONA REBUILDS SEAL FACE ON RAW MILL AT CEMENT PLANT

Customer Location: Cement Plant, Nazareth, Pennsylvania

Application Date: March, 2007

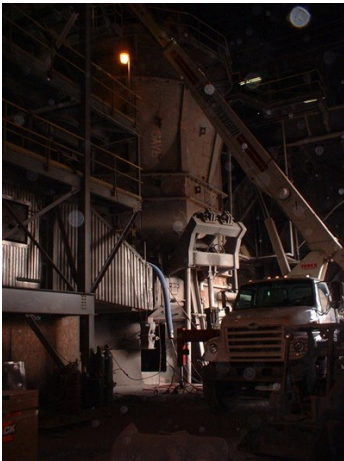
- * Raw mill overall size ,
- * Worn seal area on rotating table ,
- * Belzona® 1812 applied and new felt seal and holder installed ,
- * Another general view of the mill ,

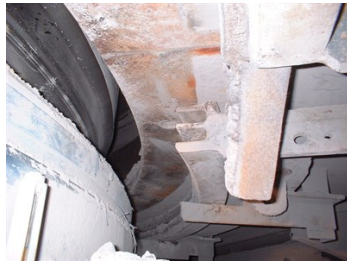
Abrasion from the felt seal and limestone wore this major component of the mill.
