# BELZONA REBUILDS SEAL FACE ON RAW MILL AT CEMENT PLANT

ID: 935

Application: SHM-Solids Handling Machinery

Customer Location: Cement Plant, Nazareth, Pennsylvania

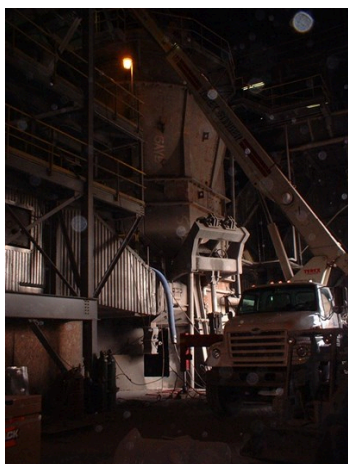
- \* Raw mill overall size ,
- \* Worn seal area on rotating table ,
- \* Belzona® 1812 applied and new felt seal and holder installed ,
- \* Another general view of the mill ,

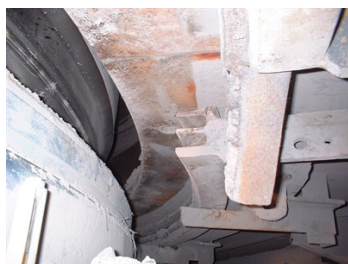
*Abrasion from the felt seal and limestone wore this major component of the mill.*

Application was carried out in accordance with Belzona Know-How System Leaflet SHM-13. Limited access only allowed hand grinding for preparation followed by application of the Belzona® 1812 by trowel.
