Belzona smooths out competition

ID: 9350

Industry: Buildings & Structures
Application: FPA-Floor Problem Areas
Substrate: Concrete
Products: Belzona 2221 (MP Fluid Elastomer), Belzona 4111 (Magma-Quartz), Belzona 5231 (SG Laminate)

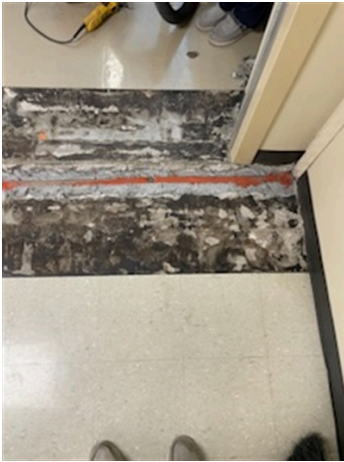
The expansion joint had been damaged and breaking up grout from North to the west end surgical area.

Removing existing expansion joint

Removed old expansion joint and chipped out grout around area. Grinded down concrete to make a smooth transition. Built up concrete with Belzona 4111, created expansion joint with Belzona 2221 and coated transition with Belzona 5231

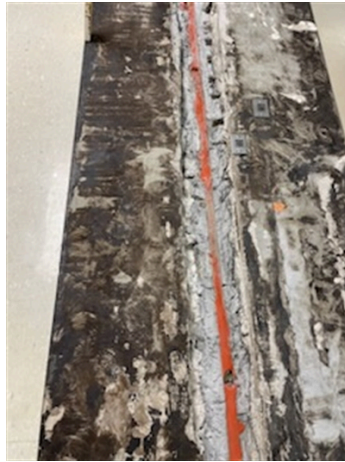
After grout was removed

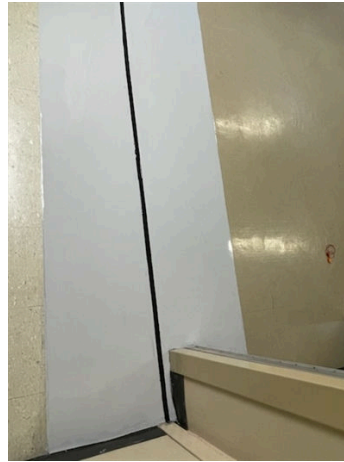
Finished smooth ride
