Belzona smooths out competition

ID: 9350

Industry: Buildings & Structures
Application: FPA-Floor Problem Areas
Substrate: Concrete
Products: Belzona 2221 (MP Fluid Elastomer), Belzona 4111 (Magma-Quartz), Belzona 5231 (SG Laminate)

Customer Location: Lafayette
Application Date: February 2024

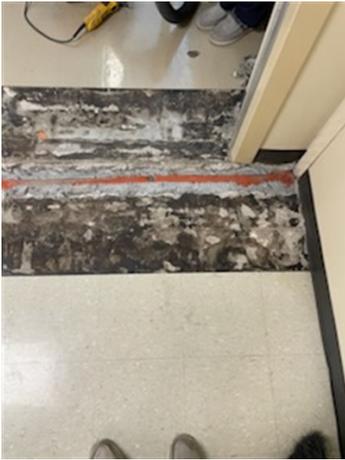
The expansion joint had been damaged and breaking up grout from North to the west end surgical area.

Removing existing expansion joint

Removed old expansion joint and chipped out grout around area. Grinded down concrete to make a smooth transition. Built up concrete with Belzona 4111, created expansion joint with Belzona 2221 and coated transition with Belzona 5231

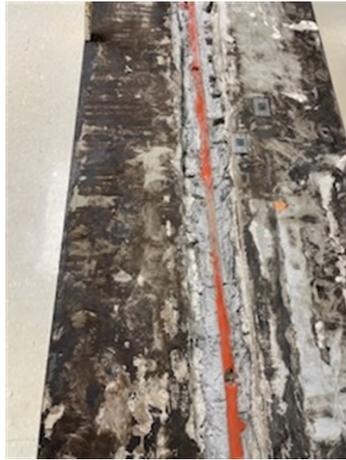
After grout was removed

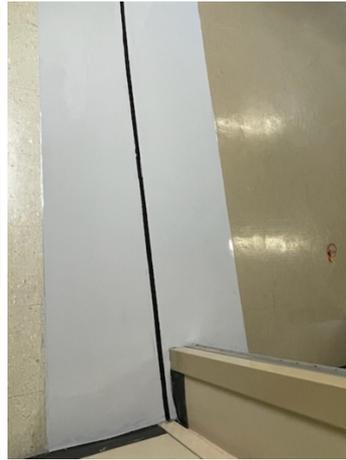
Finished smooth ride

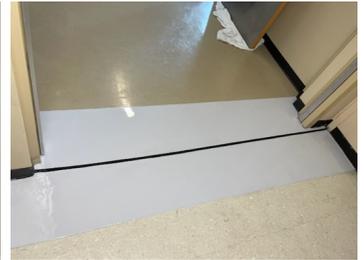
completed smooth ride application
