Leaking Porous Weld Repair

Industry: Water / Wastewater

Application: VPF-Valves, Pipes and Fittings

Substrate: Stainless-steel

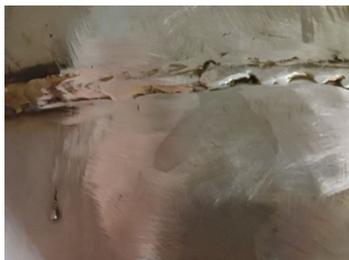
Weld Joint on stainless steel pipe was leaking due to a porosity and slag inclusion

Repair area preparation completed

Preparation was completed in-way of using a grinder with a 80 grit sanding pad, than cleaned with Belzona 9111. Next the Belzona 1111 repair composite was mixed and applied well into the preferred area. Using a piece of Belzona 9341 Reinforcing cloth was wetted out and applied over the repair area with a further layer of Belzona 1111 until the cloth was covered.

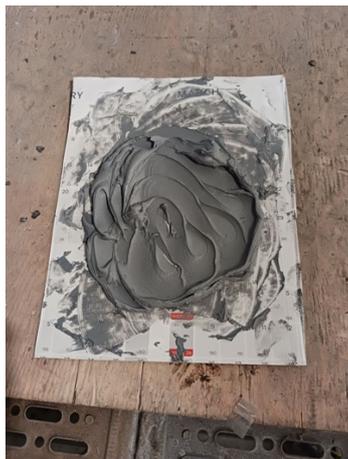
Belzona 1111 mixed

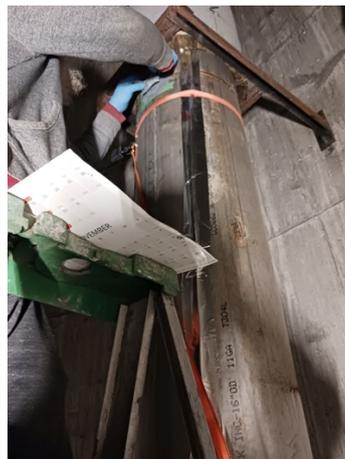
Application of Belzona 1111

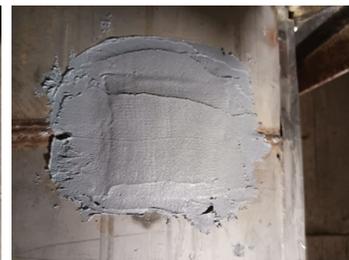
Application completed
