# Diffuser ring resurface and coated with Belzona

ID: 9353

Application: CEP-Centrifugal Pumps

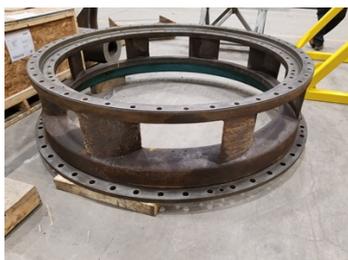
Diffuser ring was corroded and certain areas were worn out and needed to be resurfaced.

Initial state of the ring.

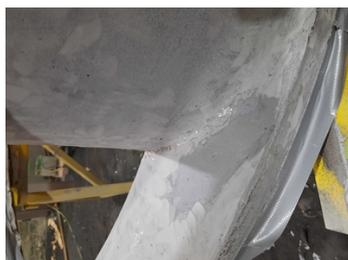
Resurfacing with Belzona 1111.

The inner surface of the ring was resurfaced with Belzona 1111 and then it was followed by two coats of Belzona 1341.

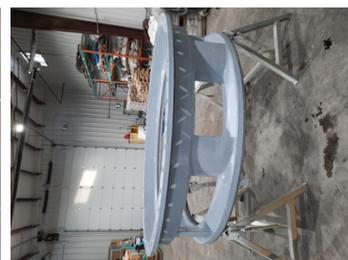
After application of 2nd coat.
