# Pump bearing housing repair in situ

ID: 9355

Industry: Marine  
Application: CEP-Centrifugal Pumps  
Substrate: Carbon steel  
Products: Belzona 1121 (Super XL-Metal), Belzona 9411 (Release Agent)

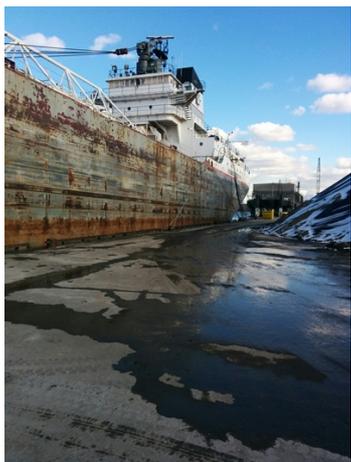
Outside look at the vessel

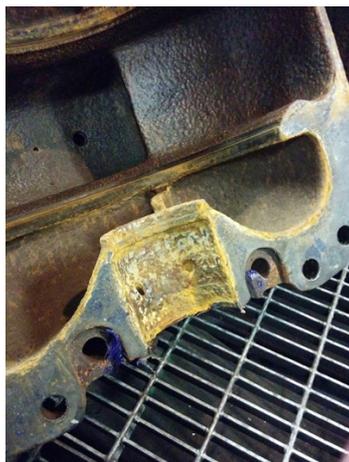
Upon removal of the top casing, the pump was inspected. It was determined that the bush seating was suffering from corrosion and wear and needed to be rebuilt.

Damaged bearing housing

A light weight former was pre-fabricated, which was coated with Belzona 9411 (Release agent) to allow for easier disassembly once the rebuilding material has cured. The damaged area was manually ground and cleaned prior to the application of there building material. Belzona 1121 (Super XL-Metal) was used as the rebuilding material. The product was mixed and applied over the damaged area and then the former was pressed against the product to achieve the desired dimensions. The former was removed after the product was fully cured.

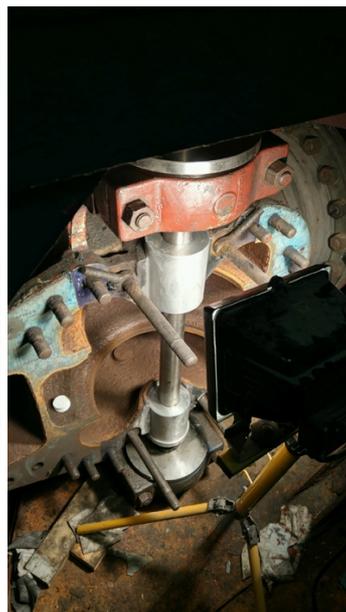
Belzona 1121 applied with formers in place

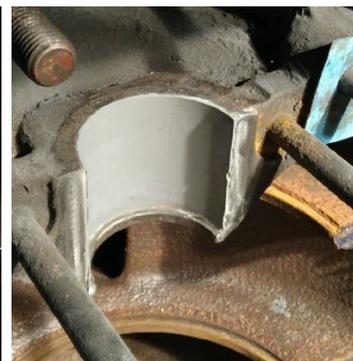
Look at the bearing housing once the former was removed
