Pump bearing housing repair in situ

ID: 9355

Industry: Marine
Application: CEP-Centrifugal Pumps
Substrate: Carbon steel
Products: Belzona 1121 (Super XL-Metal), Belzona 9411 (Release Agent)

Customer Location: Ontario
Application Date: July 2017

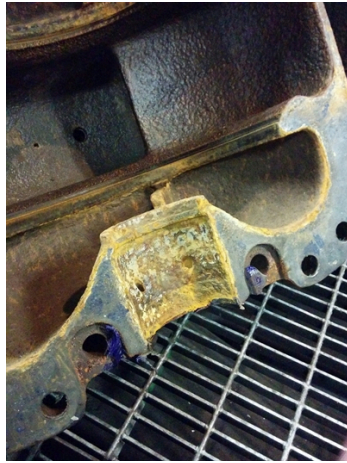
Upon removal of the top casing, the pump was inspected. It was determined that the bush seating was suffering from corrosion and wear and needed to be rebuilt.

Damaged bearing housing

A light weight former was pre-fabricated, which was coated with Belzona 9411 (Release agent) to allow for easier disassembly once the rebuilding material has cured. The damaged area was manually ground and cleaned prior to the application of there building material. Belzona 1121 (Super XL-Metal) was used as the rebuilding material. The product was mixed and applied over the damaged area and then the former was pressed against the product to achieve the desired dimensions. The former was removed after the product was fully cured.

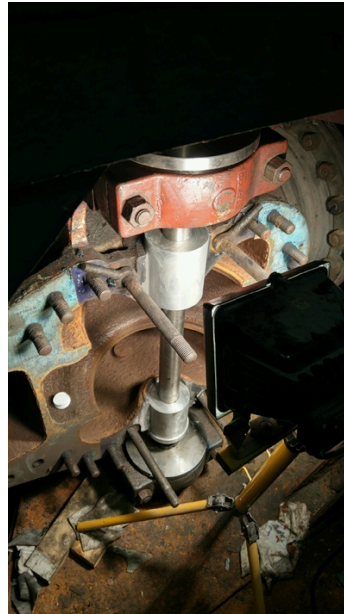
Belzona 1121 applied with formers in place

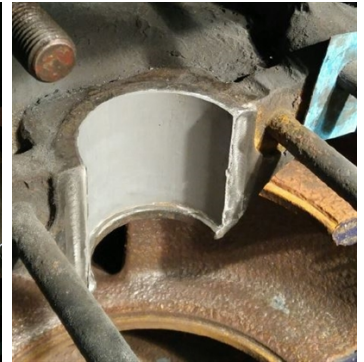
Look at the bearing housing once the former was removed
