# Pump bearing housing repair in situ

ID: 9355

Industry: *Marine* Customer Location: *Ontario*  
Application: *CEP-Centrifugal Pumps* Application Date: *July 2017*  
Substrate: *Carbon steel*  
Products: *Belzona 1121 (Super XL-Metal), Belzona 9411 (Release Agent)*

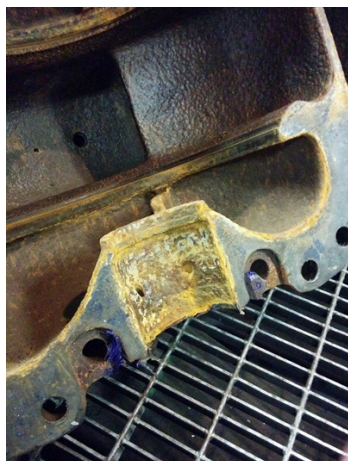
*Upon removal of the top casing, the pump was inspected. It was determined that the bush seating was suffering from corrosion and wear and needed to be rebuilt.*

Damaged bearing housing

A light weight former was pre-fabricated, which was coated with Belzona 9411(Release agent) to allow for easier disassembly once the rebuilding material has cured. The damaged area was manually ground and cleaned prior to the application of there building material. Belzona 1121 (Super XL-Metal) was used as the rebuilding material. The product was mixed and applied over the damaged area and then the former was pressed against the product to achieve the desired dimensions. The former was removed after the product was fully cured.

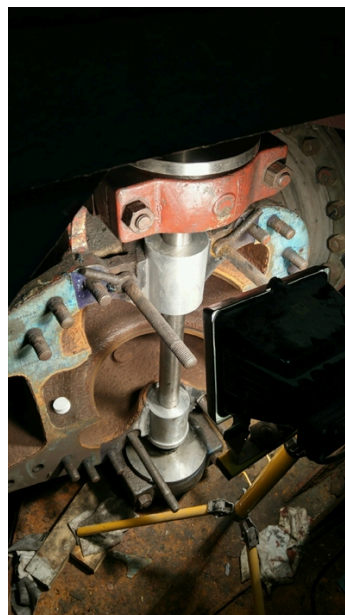
Belzona 1121 applied with formers in place

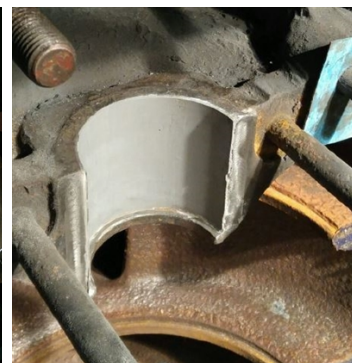
Look at the bearing housing once the former was removed
