Repairing the shaft of a vintage air handler unit, aged over 50 years

ID: 9356

Application: FBC-Fans, Blowers and Compressors

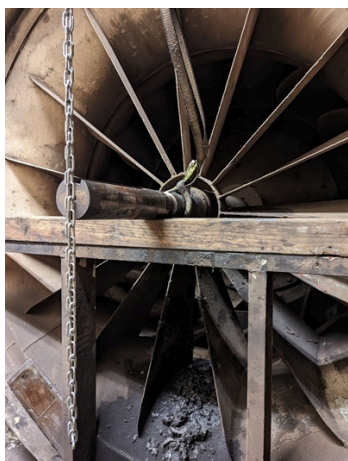
Tackling a demanding repair job on an air handler unit presented a unique challenge: its placement in a notoriously inaccessible area rendered removal or replacement nearly impracticable as it was located at a more than 50-year-old facility.

Air handler Unit

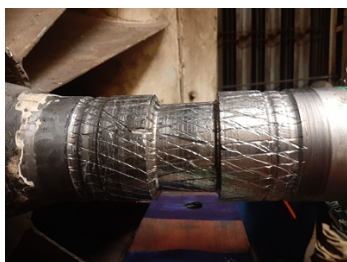
Shaft after surface preparation

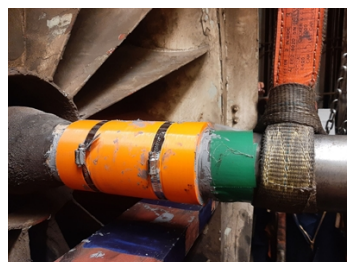
In-situ repair with 3D mold

As it was very challenging to remove the shaft for the repair, Belzona has offered in-situ repair with the use of 3D mold. By doing this, the client has shortened the air handling unit's maintenance time.

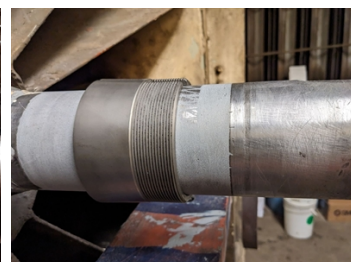
Successful repair

We devised a solution that conserved our client's precious time and resources by employing a smart on-site repair approach. Utilizing a 3D mold, we adeptly restored the shaft, guaranteeing its peak functionality. This project exemplifies our unwavering commitment to delivering exceptional service to our clientele.
