Belzona Rebuilds and Resurfaces Ships Tail Shaft

ID: 9357

Industry: Marine
Application: SOS-Ships and Offshore Structures

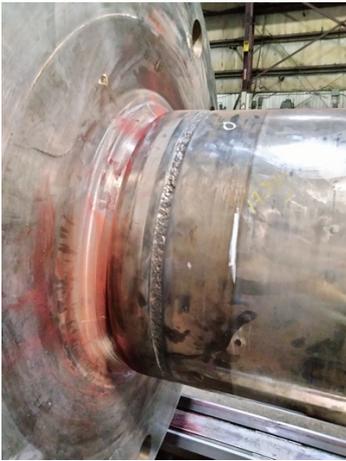
Shaft preparation completed for rebuilding

Preparation was carried out using hand tooling, cleaned using Belzona 9111 as per the Instruction For Use (IFU) the products, Belzona 1111 was used for rebuilding and Belzona 1331 was used for a protective coating for it offers erosion and corrosion resistance and can be applied with a heavy single coat without sagging.

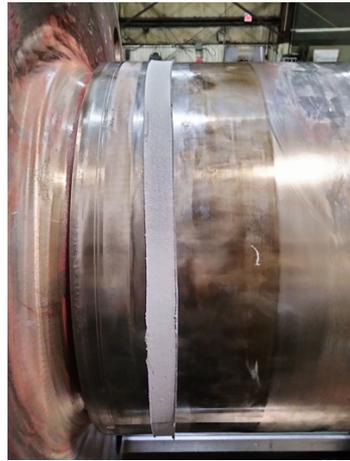
Belzona 1111 application finished and ready for machining

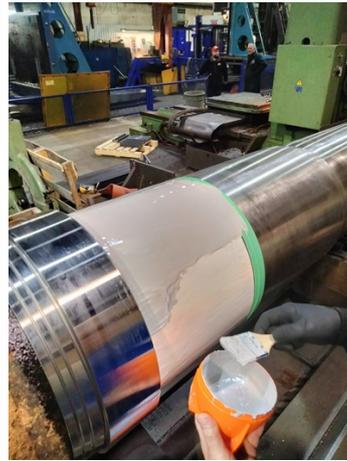
Application of Belzona 1331 second coat

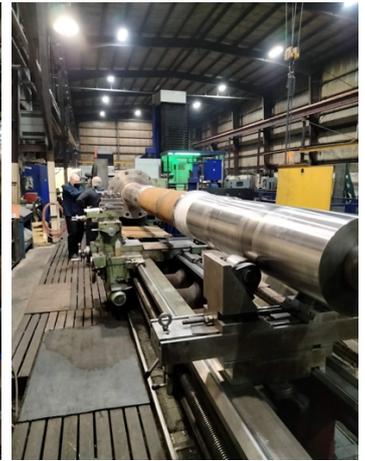
Shaft repair areas waiting on cure times so the machine shop can machine to the correct measurements.
