Belzona SuperWrap II restores pipe integrity

ID: 9360

Industry: Chemical & Petrochemical
Application: VPF-Valves, Pipes and Fittings
Substrate: Carbon steel
Products: Belzona 1212, Belzona 1981 (SuperWrap II)

Customer Location: United Kingdom
Application Date: February 2024

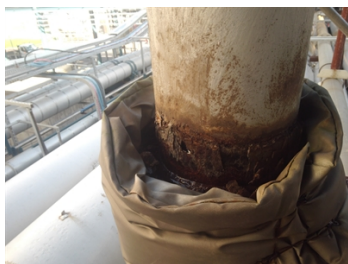
A section of cooling water pipework was corroded through wall. A repair was required to prevent any leaks occurring and to restore strength to the pipework.

Corroded pipe section

The area was cleaned & roughened using angle grinders. Belzona 1212 was then applied to fill any large pits & to fair the surface. Four overlapping wraps of Belzona SuperWrap II were then applied & consolidated with Belzona 9382

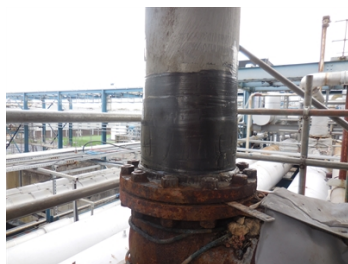
Completed repair with Belzona 1981 SuperWrap 2 installed

This repair was completed in one day with minimal disruption to the surrounding plant operations. The high strength of the system will ensure pipe integrity even if corrosion continues to occur on the underlying metal.
