Submersible Multi Stage Pump Repairs and Coatings

ID: 9361

Application: CEP-Centrifugal Pumps

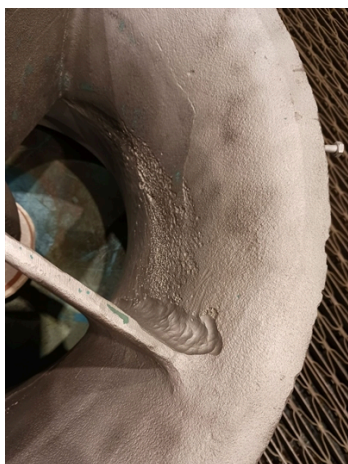
Preparation in progress for rebuilding of pumps bowls and suction bell as per the IFU

pumps were dismantled by the site's maintenance team and all parts of the equipment received grit blasting and than cleaned using Belzona 9111. All areas requiring rebuilding was completed using Belzona 1121 due to the extended working life and the overcoat window time. Belzona 1321 was used for the internal coating and Belzona 4311 was used on the externals of the equipment.

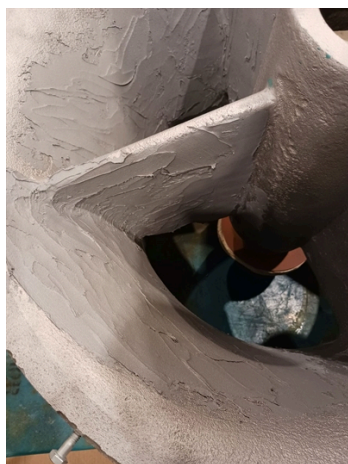
Repaired areas of pump bowls using Belzona 1121

The deep well submersible pumps are used for storm water and also see's hydrocarbons from ground water run off's, the pumps have experienced erosion and corrosion issues.

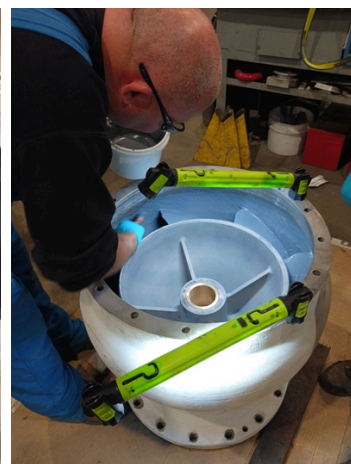
Second coat of Belzona 1321
