Belzona Saves Hospital AHU Condensate Pan

ID: 9362

Industry: Heating, Ventilation & Air Conditioning

Application: TCC-Tanks and Chemical Containment Areas

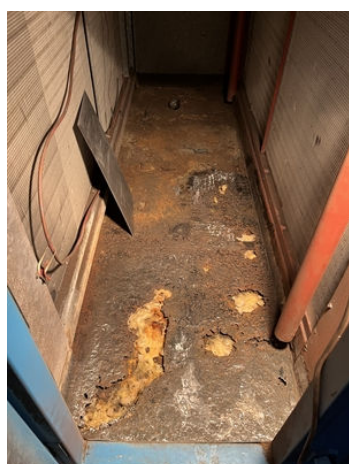
Surface preparation to reveal holes in pan and ready for cold plate bonding.

The entire pan was power tool cleaned to SSPC-SP11 bare metal cleanliness using grinders and wire wheels. The pan was then degreased with MEK. Several 6mm thick steel plates were measured and cut, then bonded into place using procedure TCC-1 with Belzona 1161. Once Belzona 1161 cured the entire pan was coated with 2 coats of Belzona 5831LT for best adhesion to a power tool cleaned surface, and anticipated humid environment.

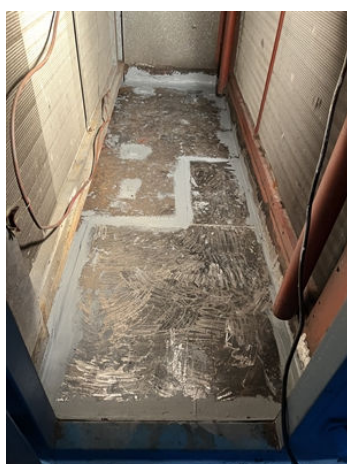
Steel doubler plates bonded into place with Belzona 1161. Edges of pan chamfered with additional Belzona 1161.

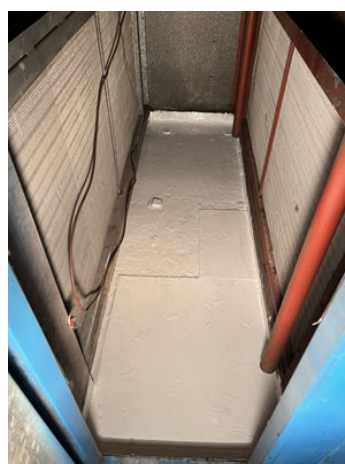
First coat of Belzona 5831LT White applied.

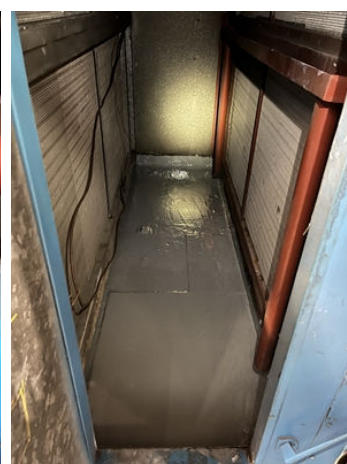
Second coat of Belzona 5831LT Grey applied.
