Belzona Saves Hospital AHU Condensate Pan

ID: 9362

Application: TCC-Tanks and Chemical Containment Areas

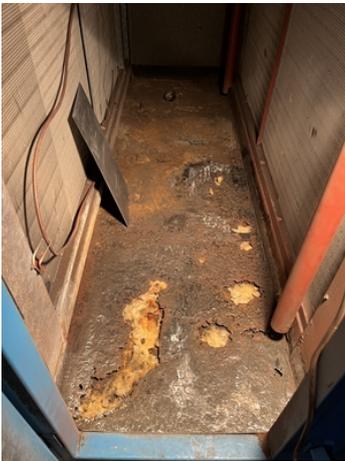
Surface preparation to reveal holes in pan and ready for cold plate bonding.

The entire pan was power tool cleaned to SSPC-SP11 bare metal cleanliness using grinders and wire wheels. The pan was then degreased with MEK. Several 6mm thick steel plates were measured and cut, then bonded into place using procedure TCC-1 with Belzona 1161. Once Belzona 1161 cured the entire pan was coated with 2 coats of Belzona 5831LT for best adhesion to a power tool cleaned surface, and anticipated humid environment.

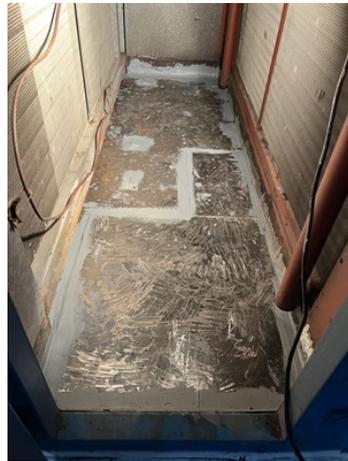
Steel doubler plates bonded into place with Belzona 1161. Edges of pan chamfered with additional Belzona 1161.

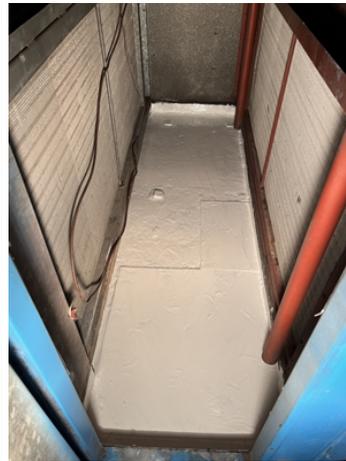
First coat of Belzona 5831LT White applied.

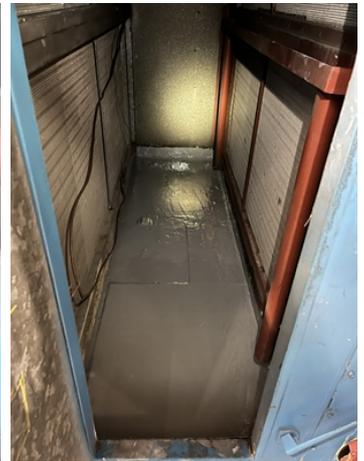
Second coat of Belzona 5831LT Grey applied.
