Belzona 5811 Exterior/Interior Columns and Head Belzona 5811/5111 Exterior 1341 Wet Interior Pitting filled with Belzona 1121

ID: 9363

Industry: Oil & Gas
Application: CEP-Centrifugal Pumps
Substrate: Carbon steel
Products: Belzona 1121 (Super XL-Metal), Belzona 1341 (Supermetalgilde), Belzona 5111 (Ceramic Cladding), Belzona 5811 (Immersion Grade)

Customer Location: Norco, Louisiana
Application Date: March 2024

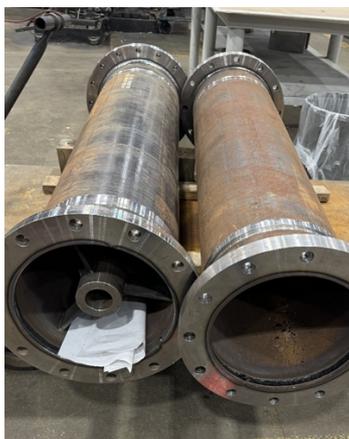
Columns Before

Extreme pitting and loss of integrity

Abrasive blast internals and externals to SSPC PC 10 (3 mil min. angular profile) as per product manufacturer's recommendations.
-Rebuild pitted areas using Belzona 1121.
-Apply Belzona 5811/5111 to exterior and Belzona 1341 interior wet areas of listed parts as per product manufacturer's recommendation as listed.
