Belzona 5811 Exterior/Interior Columns and Head Belzona 5811/5111

ID: 9363

Industry: Oil & Gas
Application: CEP-Centrifugal Pumps
Substrate: Carbon steel
Products: Belzona 1121 (Super XL-Metal), Belzona 1341 (Supermetalglide), Belzona 5111 (Ceramic Cladding), Belzona 5811 (Immersion Grade)

Customer Location: Norco, Louisiana
Application Date: March 2024

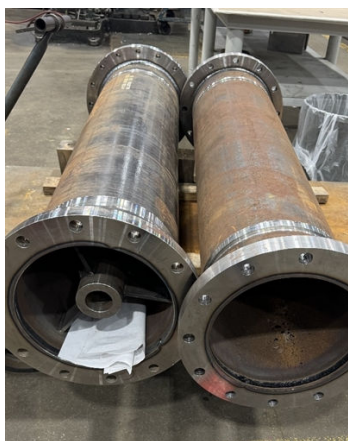
Extreme pitting and loss of integrity

Columns Before

Abrasive blast internals and externals to SSPC PC 10 (3 mil min. angular profile) as per product manufacturer's recommendations.
-Rebuild pitted areas using Belzona 1121.
-Apply Belzona 5811/5111 to exterior and Belzona 1341 interior wet areas of listed parts as per product manufacturer's recommendation as listed.

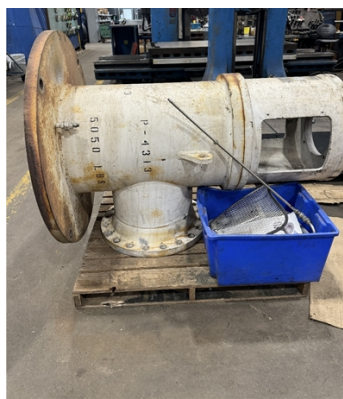
Head Before

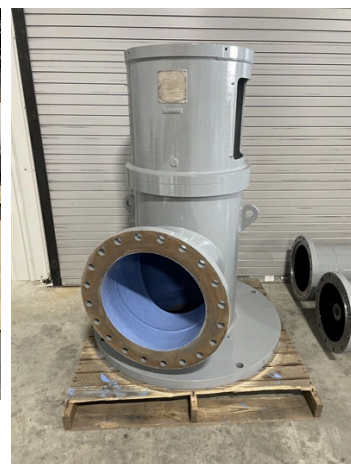
Head After Belzona 5811/5111
External/ 1341 Internal
