# Belzona 5811 Exterior/Interior Columns and Head Belzona 5811/5111

## Exterior 1341 Wet Interior Pitting filled with Belzona 1121

ID: 9363

Industry: Oil & Gas  
Application: CEP-Centrifugal Pumps  
Substrate: Carbon steel  
Products: Belzona 1121 (Super XL-Metal), Belzona 1341 (Supermetalgilde), Belzona 5111 (Ceramic Cladding), Belzona 5811 (Immersion Grade)

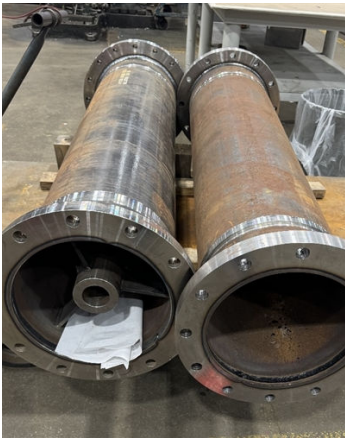
Extreme pitting and loss of integrity

Columns Before

Abrasive blast internals and externals to SSPC PC 10 (3 mil min. angular profile) as per product manufacturer's recommendations.

-Rebuild pitted areas using Belzona 1121.

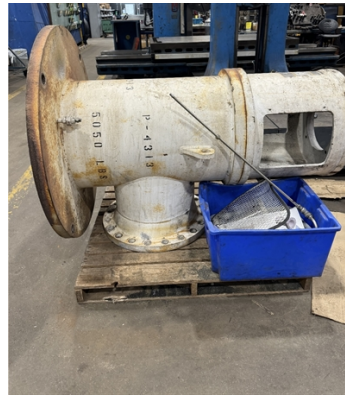
Head Before

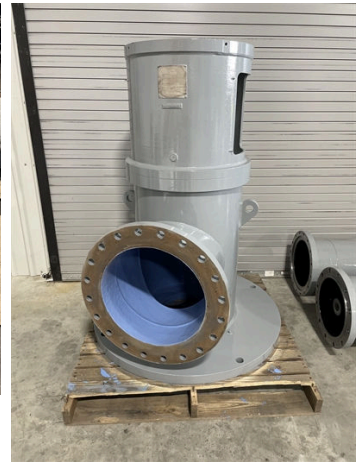
Head After Belzona 5811/5111  
External/ 1341 Internal

-Apply Belzona 5811/5111 to exterior and Belzona 1341 interior wet areas of listed parts as per product manufacturer's recommendation as listed.
