# Plate bond to repair and protect a chute that has powder lime blown through it

ID: 9366

Industry: *General Industry*  
Application: *SHM-Solids Handling Machinery*

Substrate: *Carbon steel*  
Products: *Belzona 1212, Belzona 1812 (Ceramic Carbide FP)*

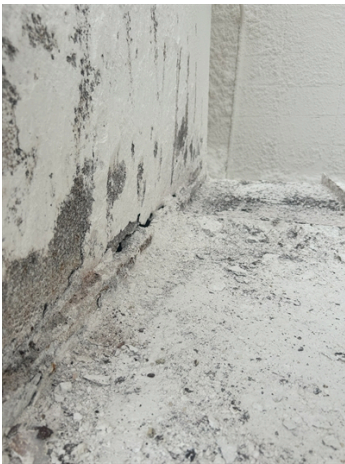
*The chute which carries powder lime had a hole in it they needed to repair in place while adding abrasion protection with Belzona 1812*

Area before being cleaned and prepared for work.

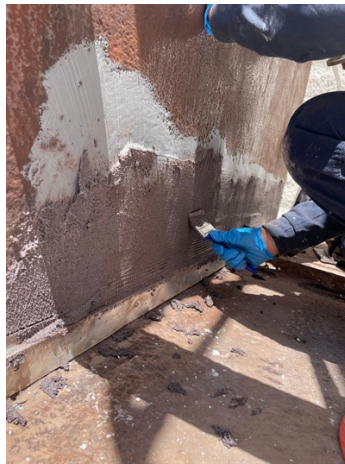
Area being prepared for application of Belzona 1212 and plate bond with Belzona 1812.

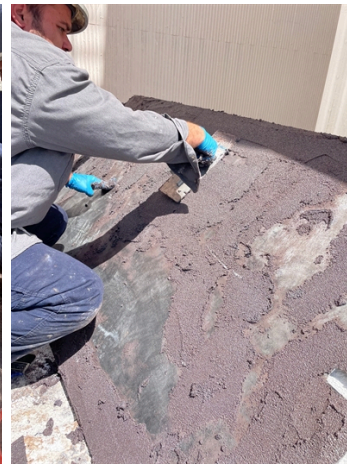
Belzona 1812 being applied to prepared plate to get ready to bond it to the chute.

Belzona application tools and short bristled brushes were used for the hand application of Belzona 1812 and Belzona 1212.

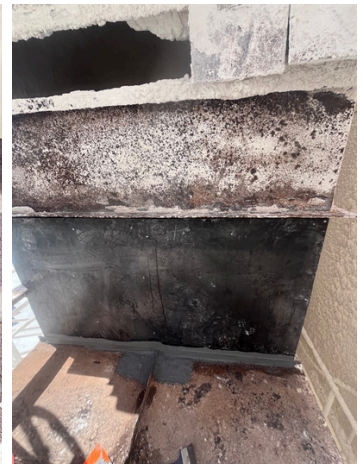
Job complete. Belzona 1212 and reinforcement cloth used to repair holes then a plate was boned with Belzona 1812 for abrasion protection.

The Belzona repair was the most cost effective due to being unable to weld in this area. They also wanted to add abrasion protection for the future, so a plate bond with Belzona 1812 was perfect for this.
